## VIBRATION EXPOSURE OF INDIVIDUALS USING WHEELCHAIRS OVER CONCRETE PAVER SURFACES

### SUMMARY

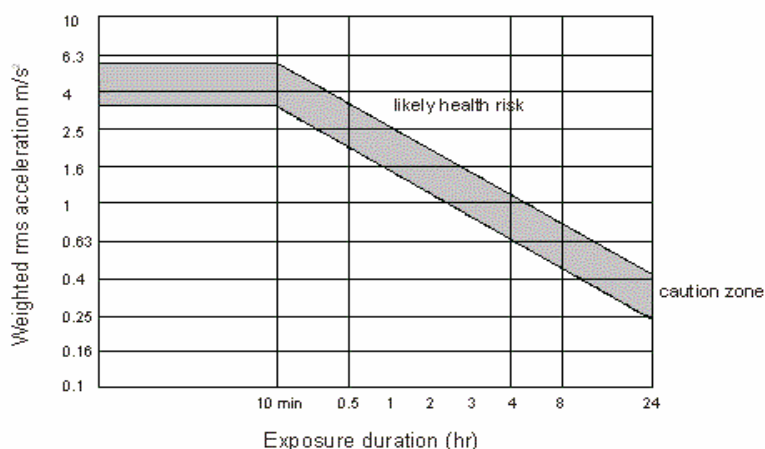
The boundaries in ISO-2631 are based on cumulative root-mean-square (RMS) amplitude over a single day, specified for frequencies between 1 Hz and 80 Hz. No allowance is made for the effect of recovery periods within a given day (20). The health guidance caution zone defines the risk for a given time period based on the average amount of vibration experienced by the user. As time progresses, the amount of vibration that someone using a wheelchair can safely tolerate decreases dramatically.

**Figure 1. Limit boundaries of vibration exposure as defined by the ISO-2631 standard**

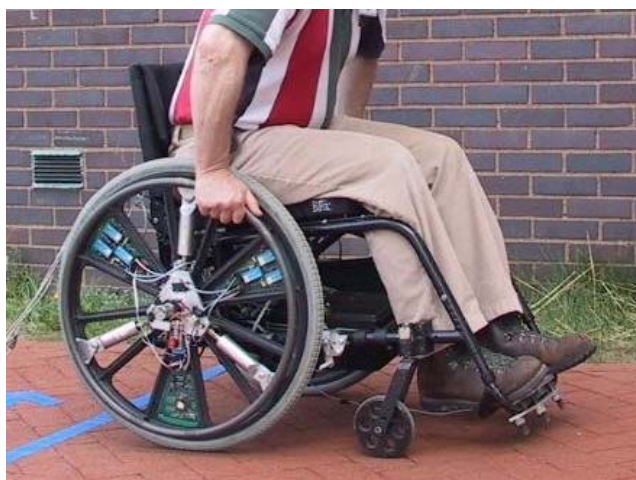
The manual wheelchair (Quickie GP, Sunrise Medical Ltd.) used was a rigid frame design with 127 mm diameter polyurethane tires, and standard 610 mm diameter rear wheels (Figure 3).

**Figure 3. Setup of the Quickie GP manual wheelchair**

The seat width, depth, and backrest height were 406 mm, 458 mm, and 410 mm respectively. The rear axles were placed 45 mm in front of the backrest tubes. SMART<sup>Wheels</sup> with solid foam inserts were

used as the rear wheels during this study (16). The mass of the manual wheelchair was 15.5 kg with the SMART<sup>Wheels</sup> attached.

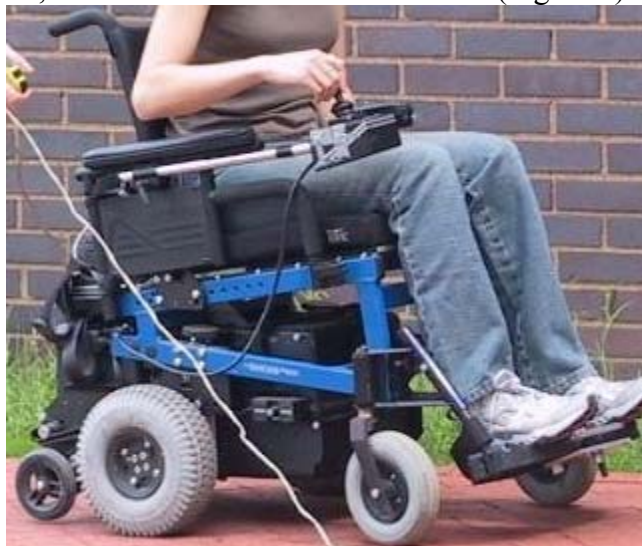
The electric powered wheelchair (Quickie P200, Sunrise Medical Ltd.) used in the study had a rigid frame with 203 mm front casters, and 254 mm diameter rear wheels (Figure 4).

**Figure 4. Setup of the Quickie P200 electric powered wheelchair**

The seat width, depth, and backrest height were 406 mm, 415 mm, and 435 mm respectively for the electric powered wheelchair. A standard position-sensing joystick was mounted to the right side armrest, and the manufacturer controller settings were used. All tires were properly inflated to the rated air pressure (0.24 MPa for the caster, and 0.34 MPa for the rear wheels). The approximate mass of the electric powered wheelchair with batteries was 89 kg. The frames of both the manual and the electric powered wheelchairs were made from aircraft quality aluminum. All subjects sat on a 50 mm thick polyurethane foam cushion during all testing.
